Mast Step

Contributed by Peter Kafer, Now or Never! P323 Hull 125

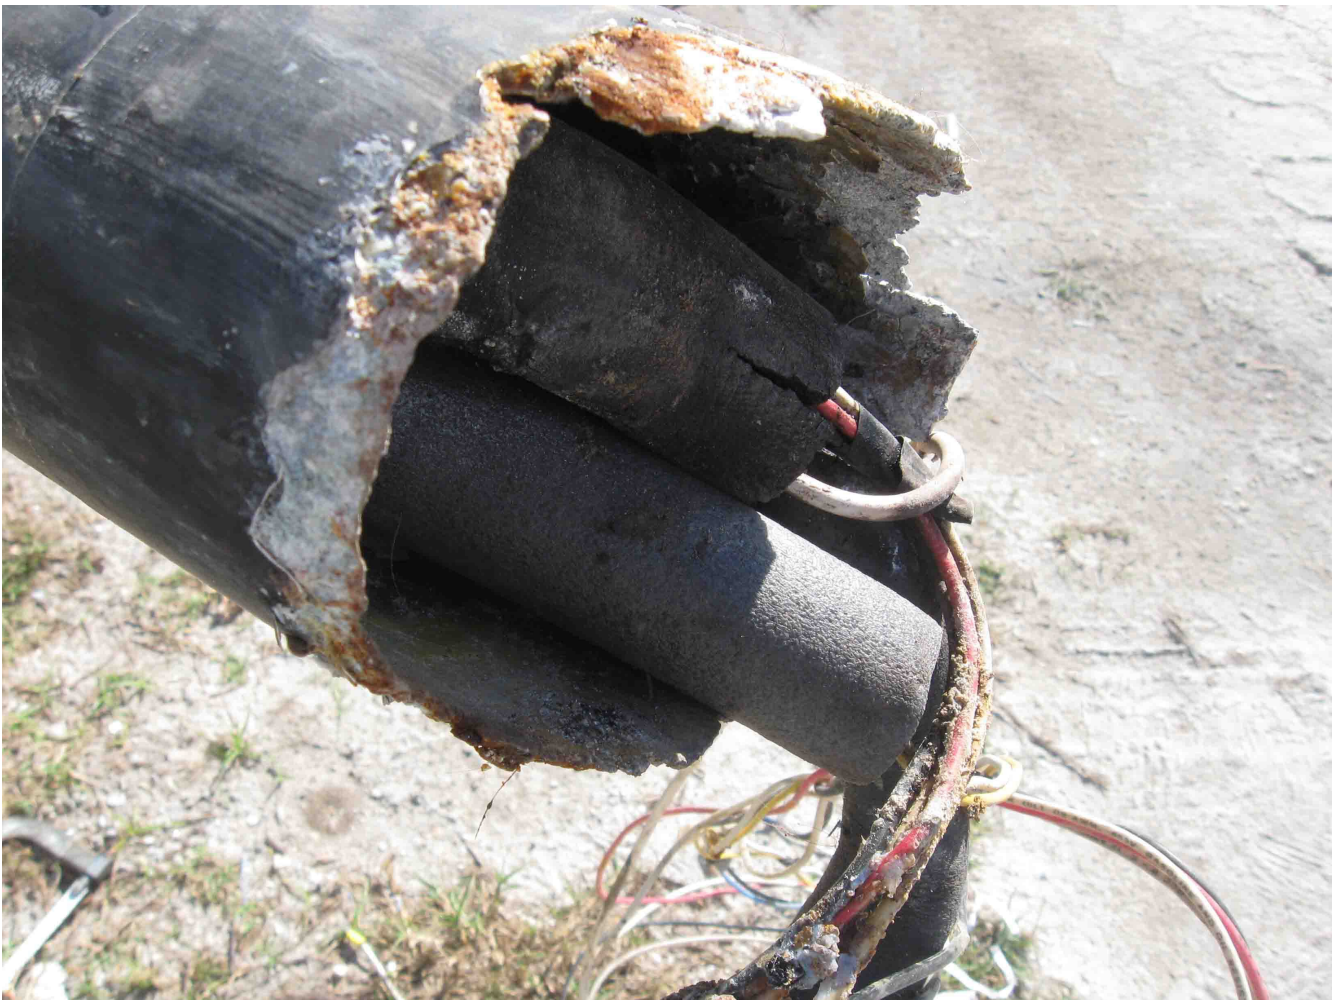
On our sail south this year, we experienced a serious problem. The corrosion at the bottom of the mast had progressed to the point that the metal could no longer withstand the forces exerted on the mast by the wind. So, the base of the mast slipped forward on the step by a generous inch. After having the stick pulled, I removed the original steel step. It was so badly corroded that it was unusable. So, I had a new step made of aluminum. I had to cut 3 1/2 inches from the base of the mast. I could probably have cut only 2 1/2 inches. The new step was built 3 1/2 inches taller than the original to compensate for the shortened mast. Unstepping the mast and re-stepping it was a piece of cake and the crane operator was very experienced. Our worries were for naught. I've attached pix of the corrosion at the base of the mast, the original step and the new step.
